Manhole Inspection Summary

Manhole # S33EE_055MH

Insp Date: **2/26/07 10:08 AM**

Location Address: **1250 MARYLAND AVE**

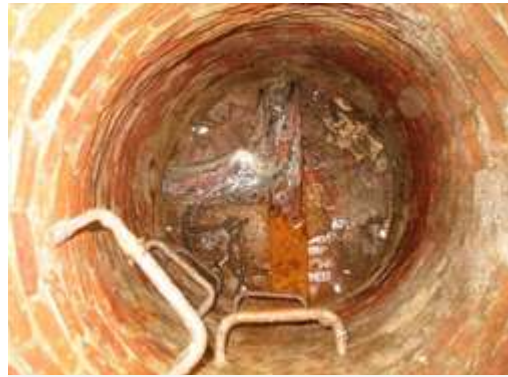
Top View

Corroded steps. Evidence of surcharge - Bench debris. Channel debris.

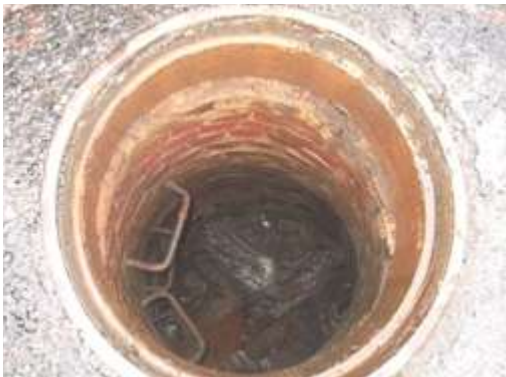
Defect

Frame leaks. Frame offset. Adjustment deterioration and infiltration.

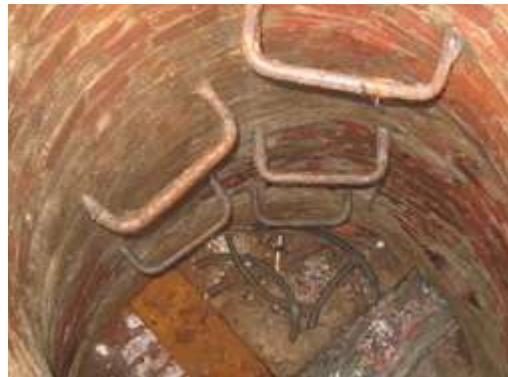
Defect

Corbel and Barrel infiltration - other side.

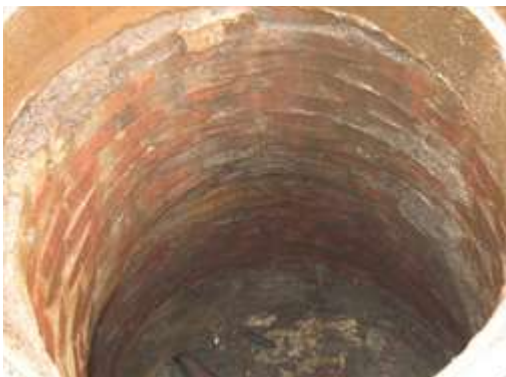
Defect

Frame leaks. Frame offset. Adjustment deterioration and infiltration. Corbel and Barrel infiltration.

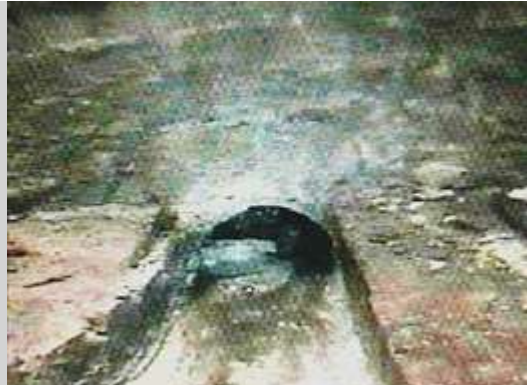
8 in. Circular Gravity Sewer Pipe Out @ 12 O'Clock

Deposits: ☐ None ☒ **Mud** ☐ Sludge ☒ **Debris** ☐ Grease

Silt Depth: **0** (in.) Deposits Extent: **Medium**

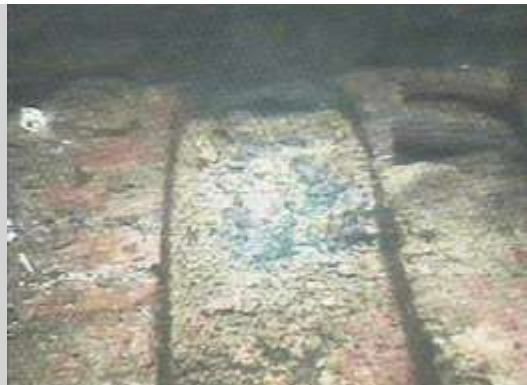
8 in. Circular Gravity Sewer Pipe In @ 6 O'Clock

CAPPED

Deposits: ☐ None ☒ **Mud** ☐ Sludge ☒ **Debris** ☐ Grease

Silt Depth: **6** (in.) Deposits Extent: **Heavy**

Infiltration: **Evidence** Pipe Seal Cond: **Unknown**

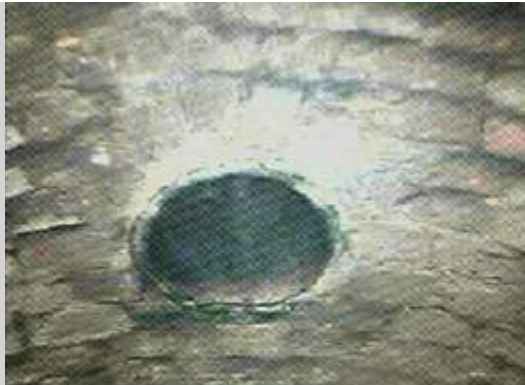
Pipe In @ 9 O'Clock

Deposits: ☐ None ☐ Mud ☐ Sludge ☐ Debris ☒ **Grease**

Silt Depth: **0.5** (in.) Deposits Extent: **Light**

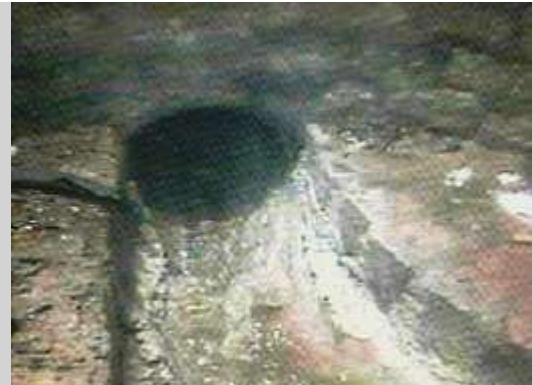
Drop In @ 9 O'Clock

Drop: **Outside** Rod and Bar

Drop Condition: **Open**
